SIO Shipyard Representative Bi-Weekly Progress Report		
<b>Project: AGOR 28</b>	<b>Contract No.: N00014-12-C-0305</b>	<b>Shipyard: Dakota Creek Industries</b>
<b>Prepared by:</b> Paul D. Bueren Scripps Institution of Oceanography (SIO) 297 Rosecrans St. San Diego, CA 98106	<b>Date:</b> <b>22 November, 2013</b>	<b>Program Officer:</b> Robert (Tim) Schnoor Office of Naval Research 875 Randolph St ONR 321 Arlington, VA 22203-1995
<b>Distribution Statement A:</b> Approved for public release; distribution unlimited.		<b>Report No. A002.045</b>

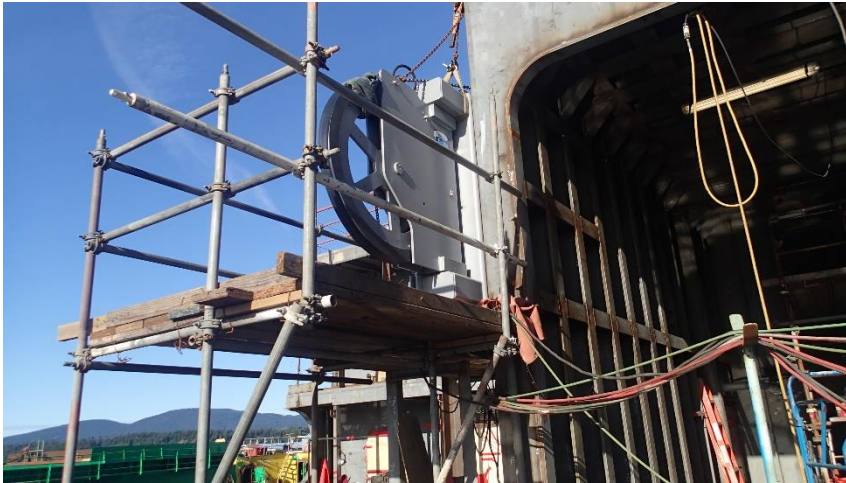
- Neil Armstrong Flag Block Deck Penetration – The penetration is being cut and the drawings are to be reviewed by ABS. The actual flag block is being mounted on the side of Armstrong's Staging Bay.

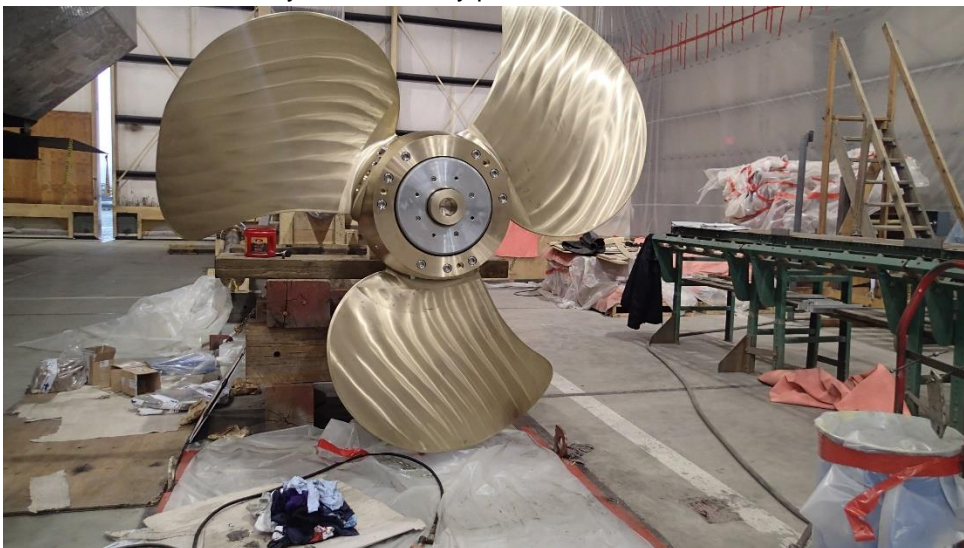
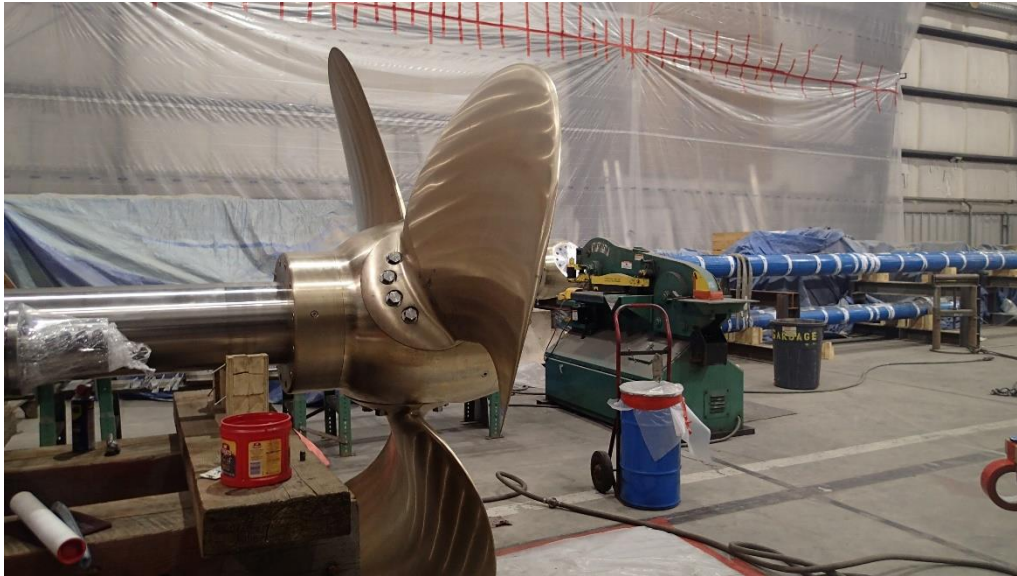
- Sally Ride Port Rudder – Inspected welds and pressure tested with ABS in attendance. No leaks found.
- Neil Armstrong CP Props – The man from Hundested was on site to install the blades to the hubs. The bolts were torqued, but the locking wire will remain off until after the pitch test has been done. 2.5-man days at a leisurely pace to do the work.

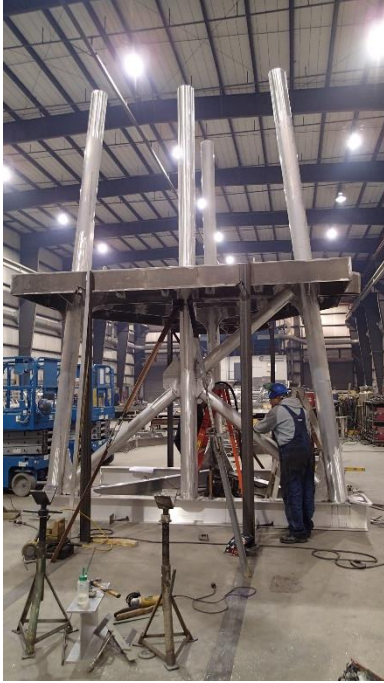
- Armstrong/Ride Main Mast– Fabrication of the masts for both ships continues, with the base for Neil Armstrong pictured below. Since this photo was taken several more large diagonals have been added to the lower structure. The remaining radar platforms for both ships are fabricated along with the upper masts sections.

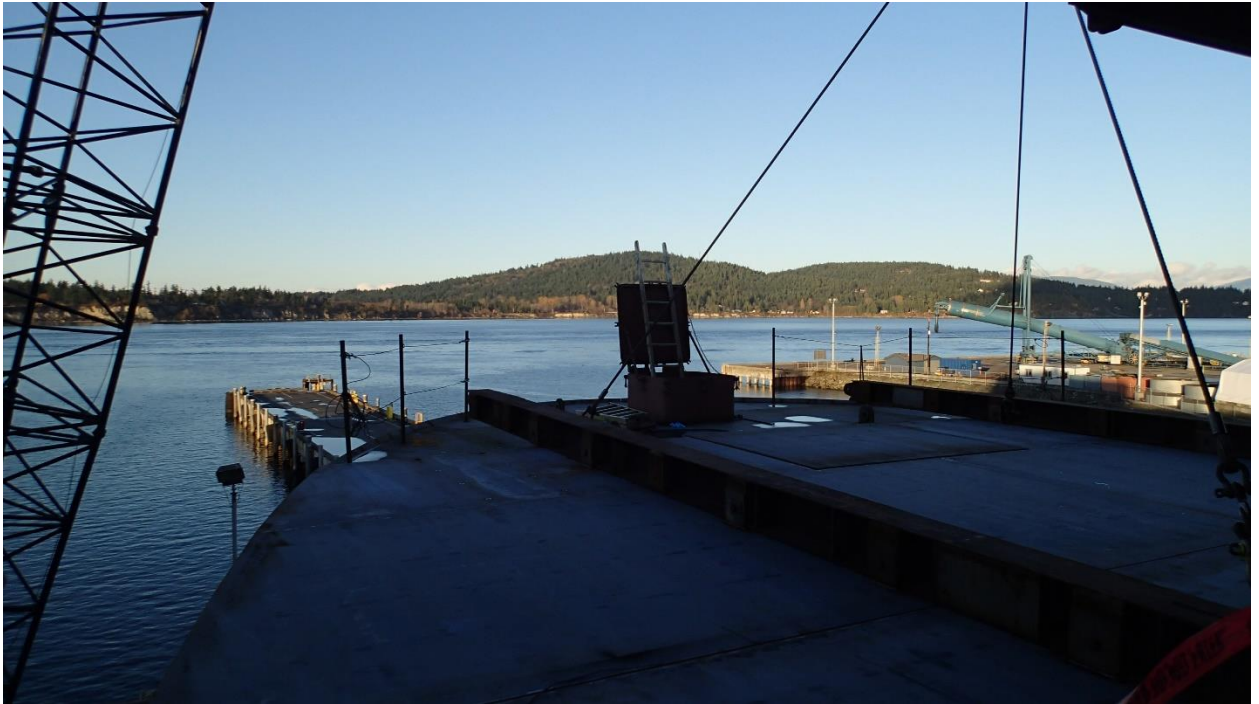
- Sally Ride Bow – The foc's'le deck was landed on the bow.
